ENVIRONMENTAL TEST REPORT

DK TECH CO., LTD.

ON FOUR (4) SPOOL ASSEMBLIES

Report No.: R24612-1
Rev.: N/C
Page 1 of 8

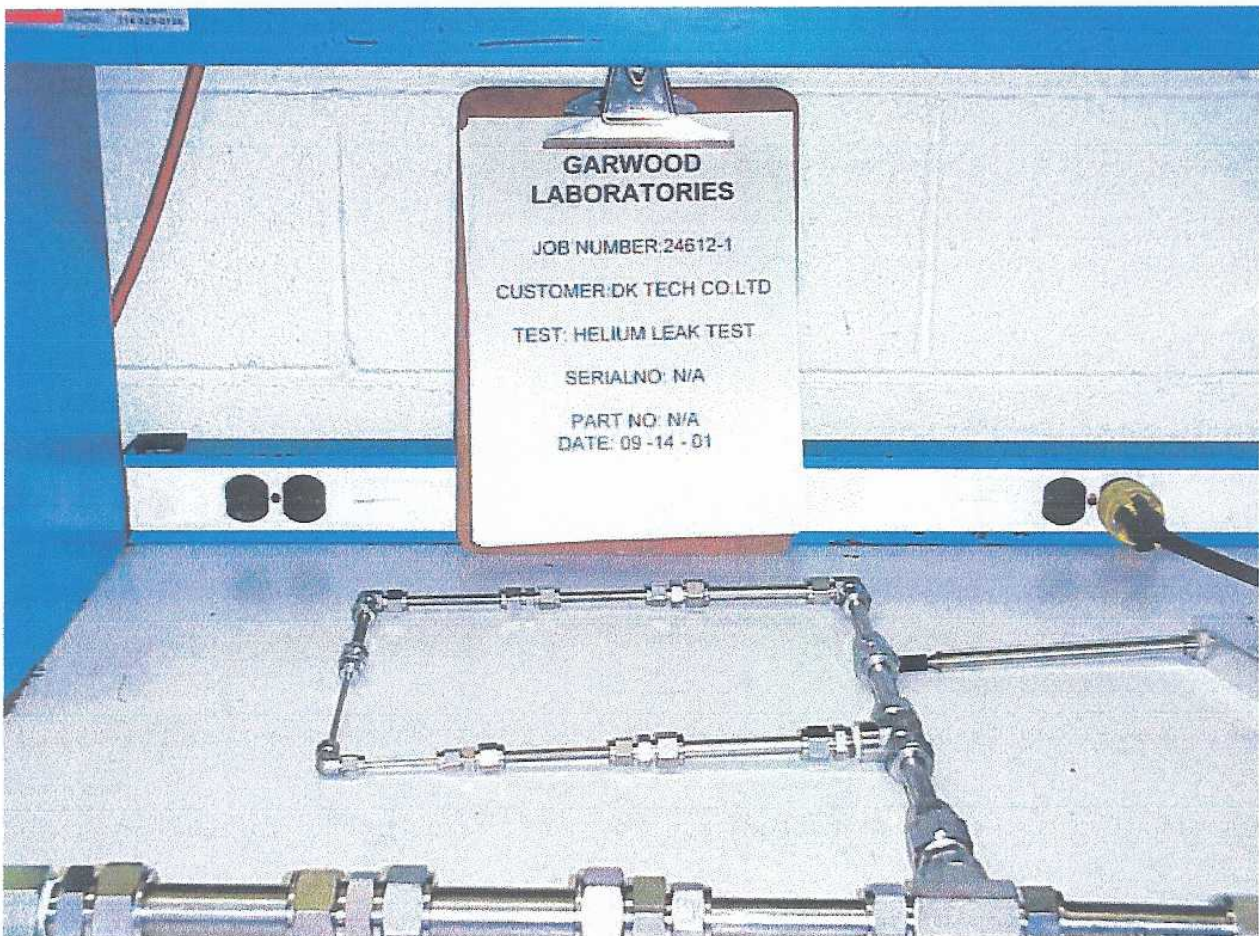
HELIUM LEAK
FOUR (4) SPOOL ASSEMBLIES
P/N: SPOOL A, B, C, D, S/N: N/A

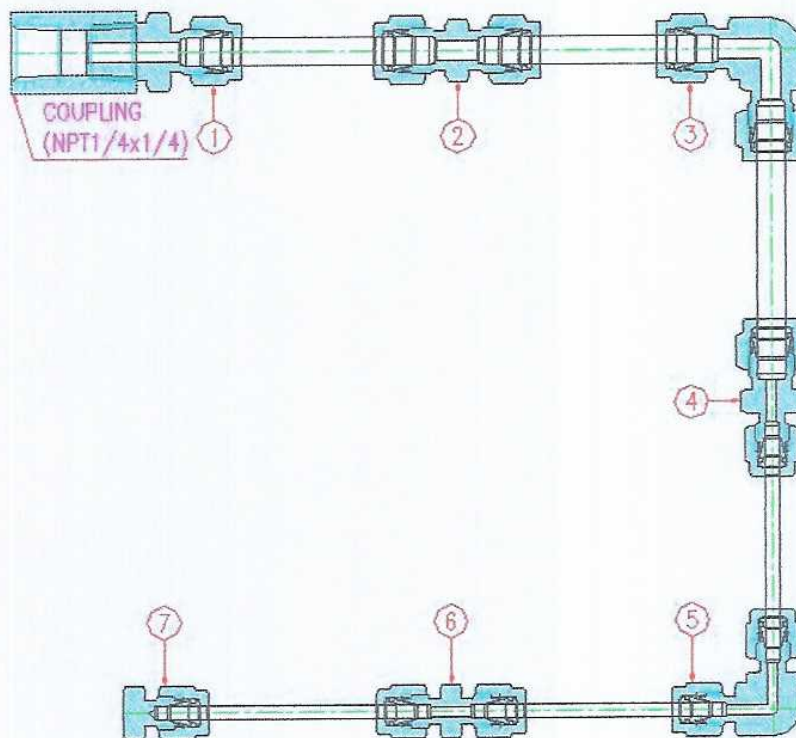
SPOOL NO. A

For tube fitting O.D. 1/8" and 1/4"

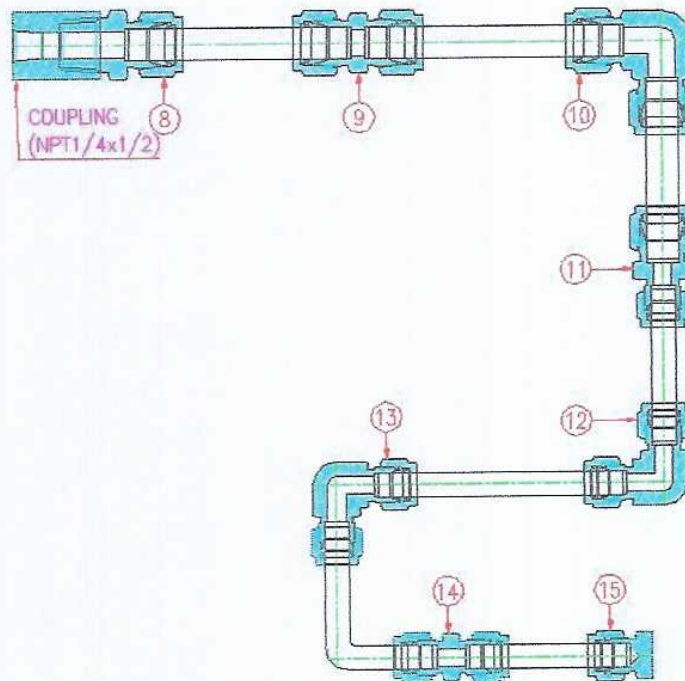
SPOOL NO. B

For tube fitting O.D. 3/8" and 1/2"

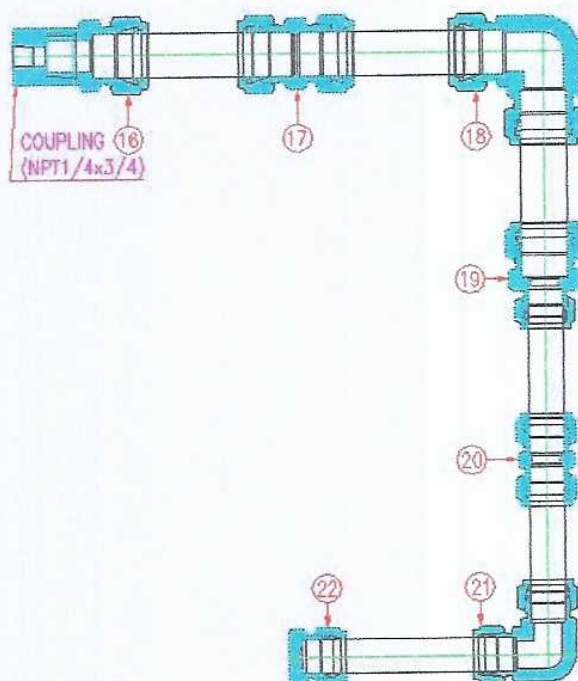
SPOOL NO. C

For tube fitting O.D. 3/4" and 1"

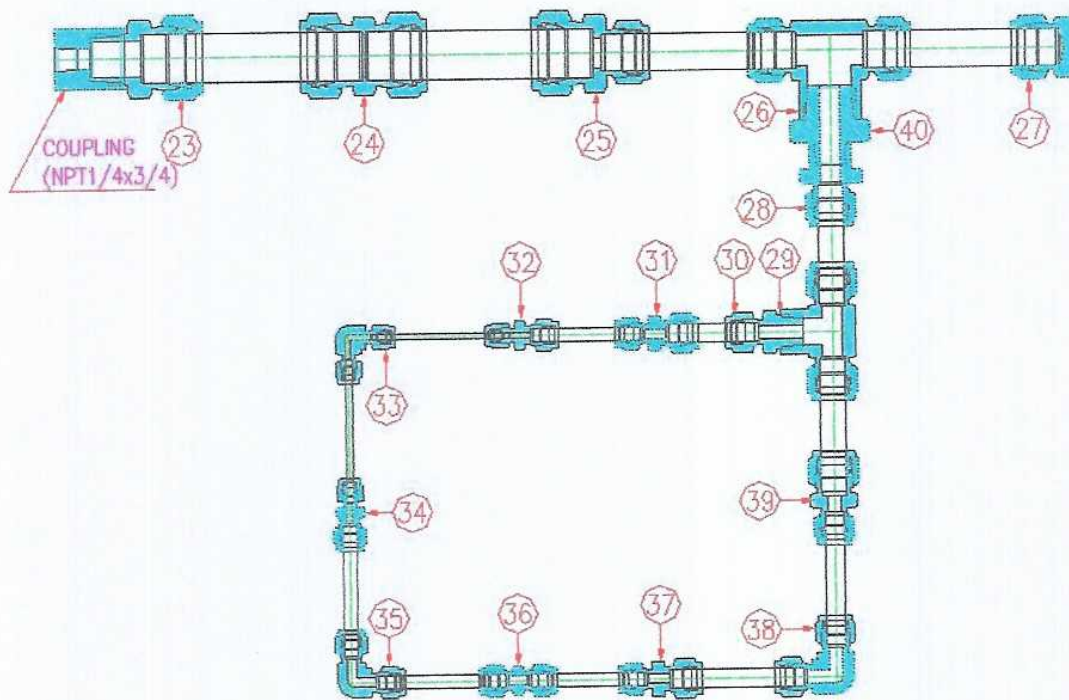
SPOOL NO. D

For Dk-Lok tube fitting O.D. 1/8" to 1"
